*Western
Union*

October 1961

CONTENTS FOR OCTOBER 1961

Plan 115 Switching System

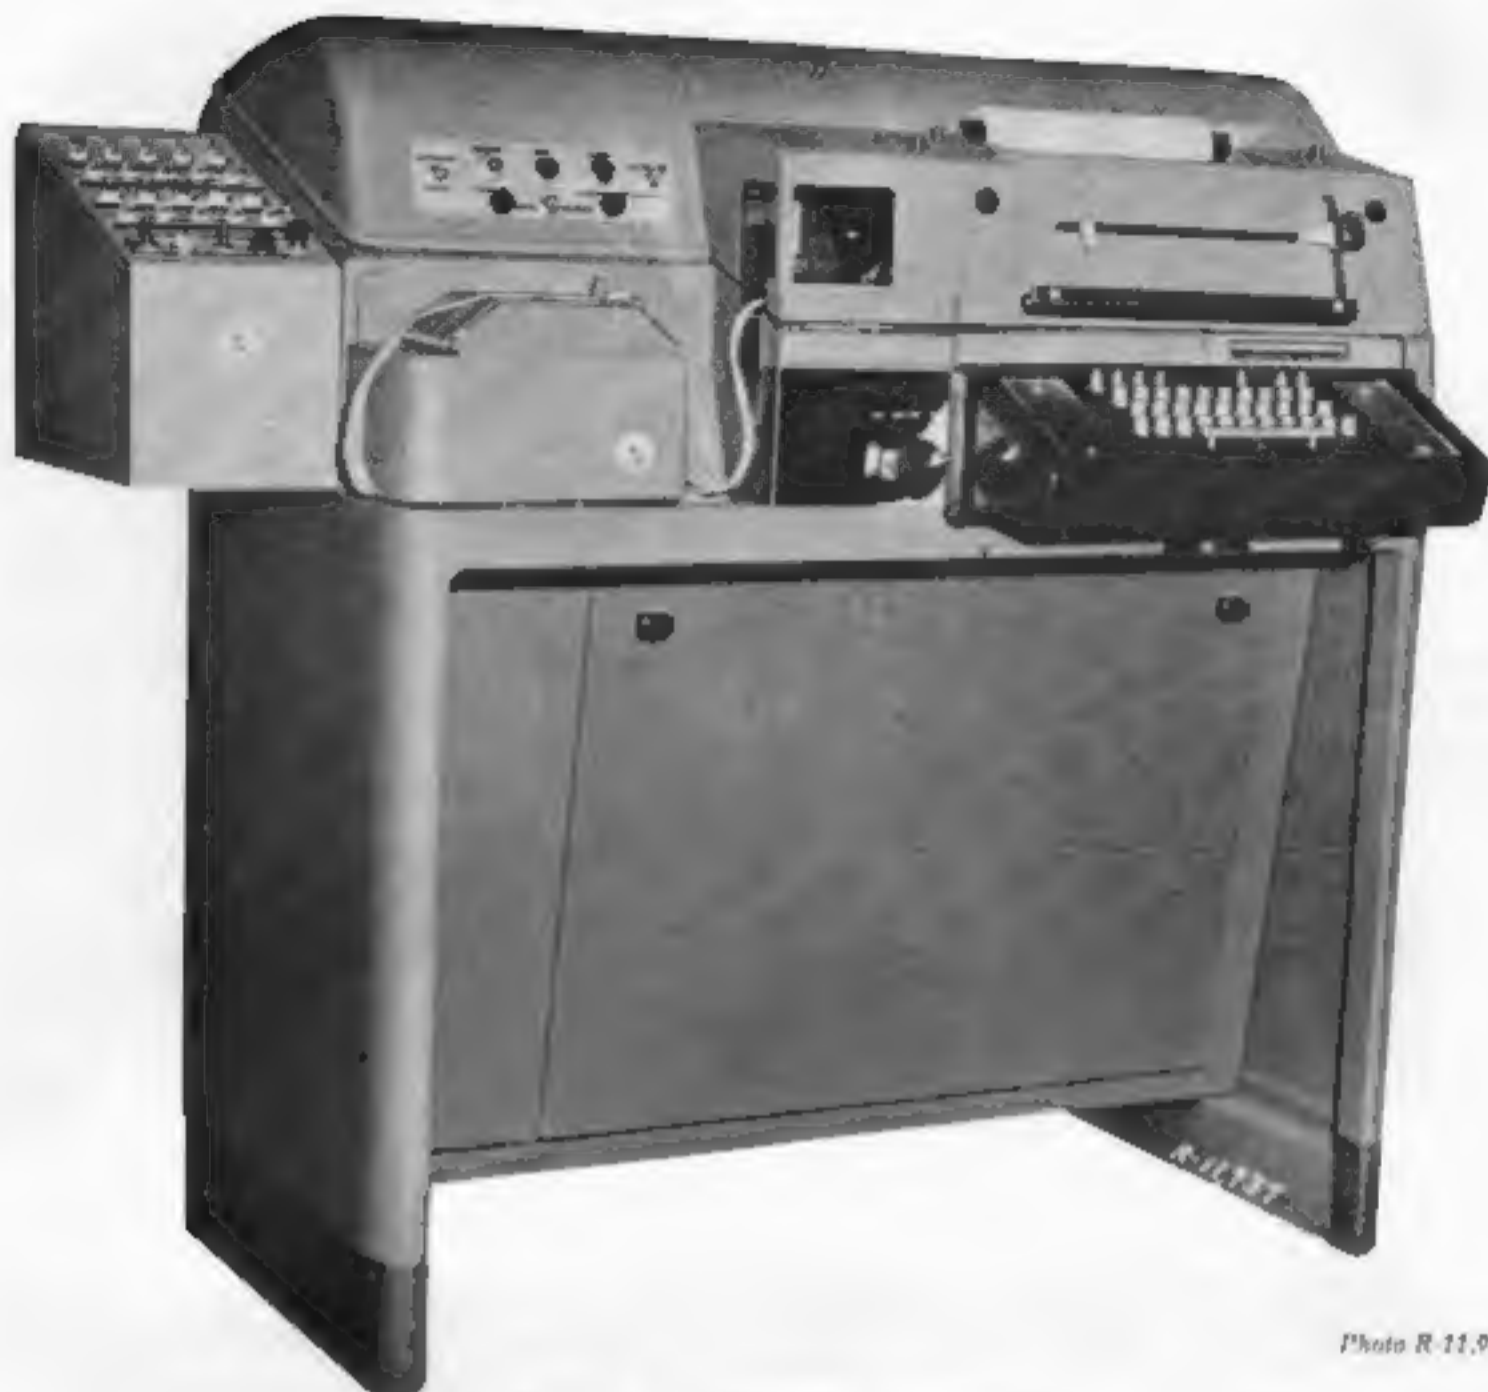
Photo R-11,917

Figure 2. Control Station Selector 10410-A

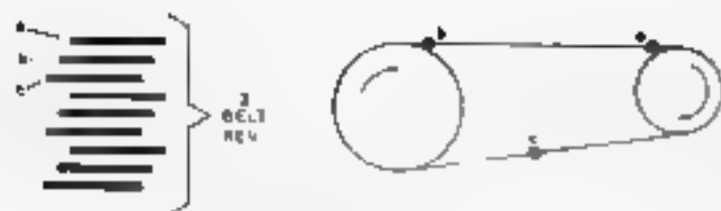
This pattern indicates that one stylus (a) is leading, needing adjustment to the left, and another (c) is lagging, needing adjustment to the right. Obviously identi-

Figure 7. Three (live styls)

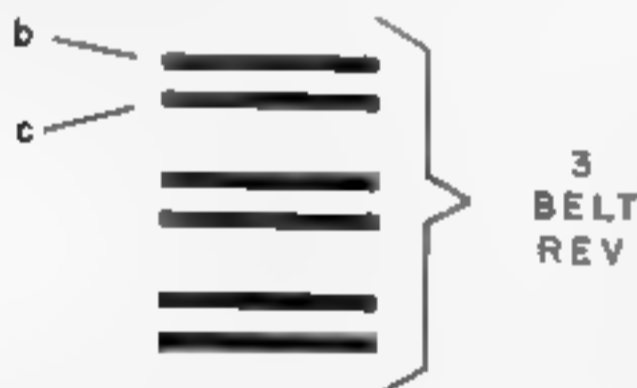
This pattern suggests that the stylus (b) following the dummy space needs adjustment to the left (counterclockwise rotation of the stylus adjusting screw), and/or the stylus (c) preceding the dummy space needs adjustment to the right (clockwise rotation of the adjusting screw). If after the adjustments are made test copy appears as in Figure 9, this stage of adjustment is satisfactory

Figure 9. Pattern of Figure 8 after corrective adjustment

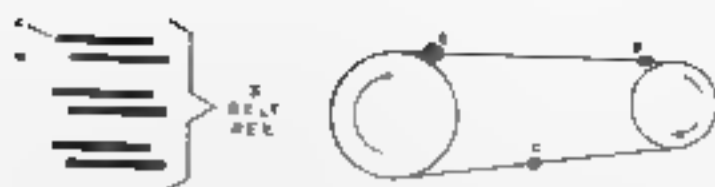
Next, move the dummy stylus backward (to the left) one stylus position (b), and place a recording stylus in the position (a) vacated by the dummy. Take an inch or two of test copy which will appear as shown in Figure 10.

Figure 10. Dummy moved backward (to left) one position. Live stylus in former dummy position (a)
